## CEM60 R.A. Play Identification and Fixing

July 28, 2014 Internal use only

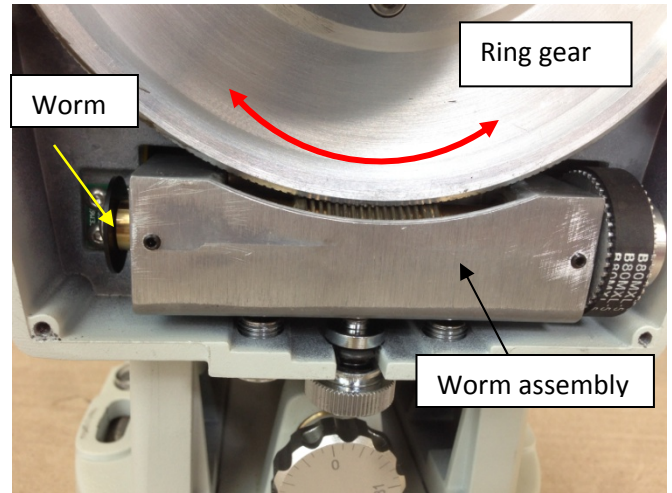
3. Adjust the RA gear switch to make a proper gear meshing as the mount is under operation. There should not have any gap between the worm and gear. Now gently turn the RA axle, check which part is moving. If only the ring gear is moving as indicated, the gear switch is not engaged.

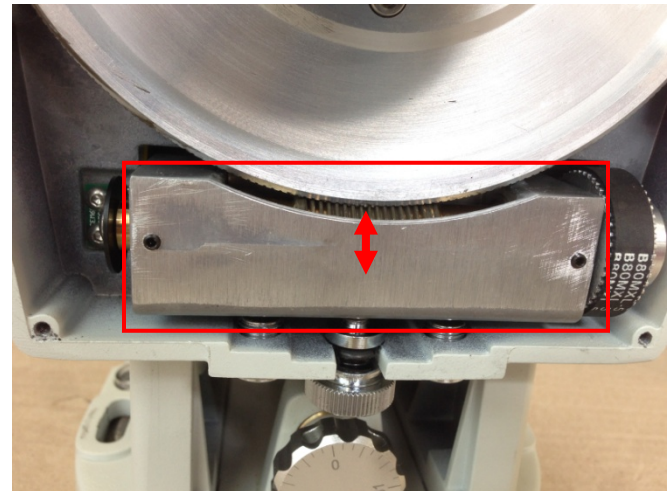
4. If the RA worm assembly is moving slightly up and down with quite a bit force applied, the gear is meshed properly. The magnetic force is holding the worm in place.

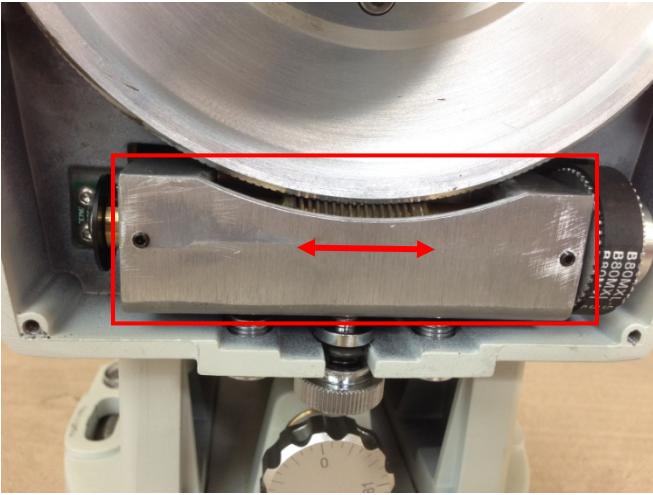
5. If the RA worm assembly is moving left and right with turning the RA axle gently, it means there is a small gap between the RA worm assembly and mounting house. It can be eliminated by tightening the bearing end caps. **Refer to Step 7 for how to fix.**

7. **To fix RA worm assembly gap**, fully disengage RA gear switch and rotate the mount head to the side.

10. Release the outer locking cap a little by turning it counterclockwise (CCW) with a small screw driver. Then turn the inner position cap clockwise (CW) to eliminate any gap. Do not over tighten it. You may check it by engaging the gear switch and rotating the RA axle. Retighten the outer locking cap.

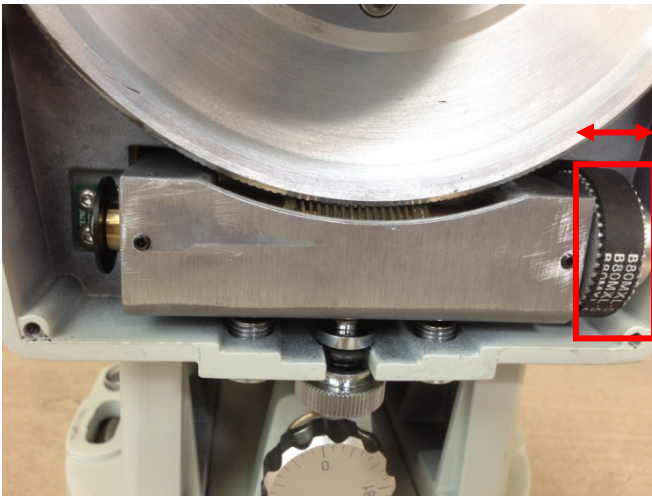
6. If the brass RA worm, or the worm pulley is moving left and right with turning the RA axle gently, there is a gap between the RA worm and worm bearing. It can be fixed by tightening the RA worm end cap.  
**Refer to Step 12 for how to fix.**

12. To fix RA worm gap, release the worm end cap locking screw.

13. Using a small screw driver to tighten the worm end cap a little bit. Be careful not to broken the PEC

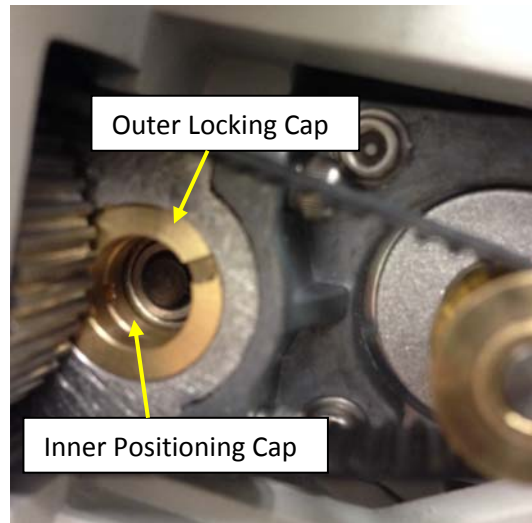
9. There are two brass locking caps that are used to secure the RA worm assembly. An inner positioning cap to tighten the bearing in place and the outer locking cap to secure the inner positioning cap.
